# PHUSICOS

Deliverable D2.4

Nature-based solutions implemented in PHUSICOS

Work Package 2 – Case study sites: large scale demonstrator sites  
and supporting concept cases

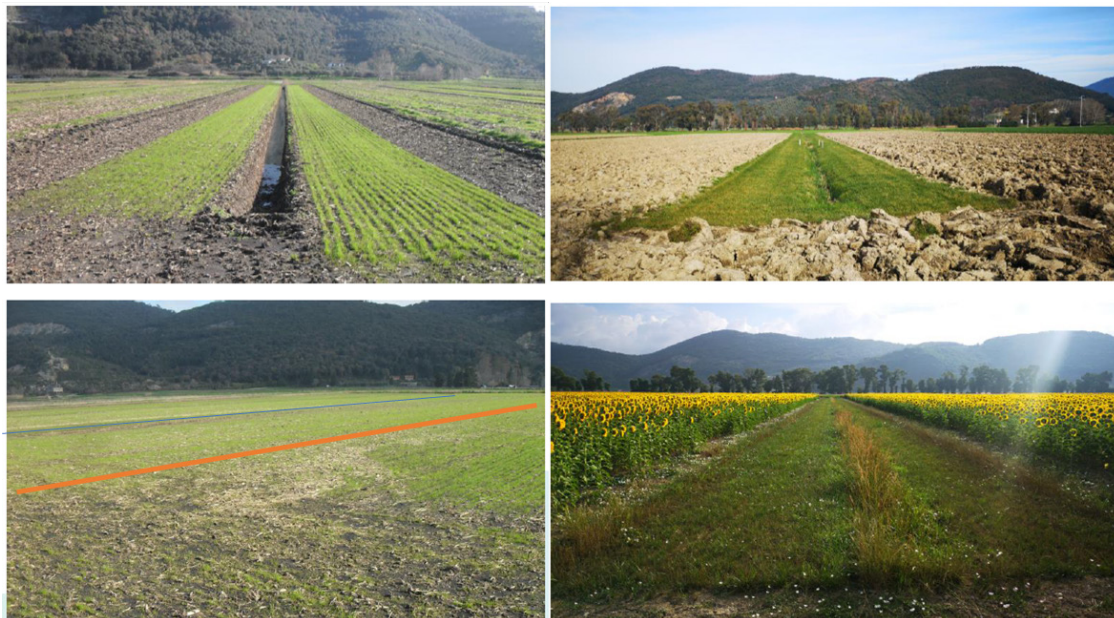
Figure 4-4 Buffer strips in the Studiati (left) and Gioia (right) areas. In the lower left photo, the orange line marks the boundary between cover crops and buffers strip, with the canal marked with a thin blue line (Photo: ADBS)

The buffer strips in the two areas were the first PHUSICPOS interventions to be completed, on 23.11.2020. The design of the strips and the selection of plants covering the strips have been done in close cooperation with University of Pisa, Italy. The strips are 3 m wide and planted with 23 kg/ha of a mix of *Festuca arundinacea* (40%), *Lolium pe-rennis* (50%), *Trifolium repens* (5%), *Trifolium subterraneum* 5% in both the Studiati area and the Gioia area (Figure 4-1, Figure 4-2, Figure 4-3, Figure 4-4). The width of the strips was a matter of discussion, and the resulting width of 3 m was a compromise between the scientific experience and the farmers' willingness to provide land. The agreement was reached through an active Living Lab process. Following this, the involved farmers showed considerably more enthusiasm and established a stronger 'ownership' to the interventions. They were also the ones to carry out the physical work, using their own machinery and personnel. In addition to preventing runoff of pollutants from the farmland, the strips will also prevent runoff of sediments and thereby clogging of the channels, which also serve as a flood mitigation measure.

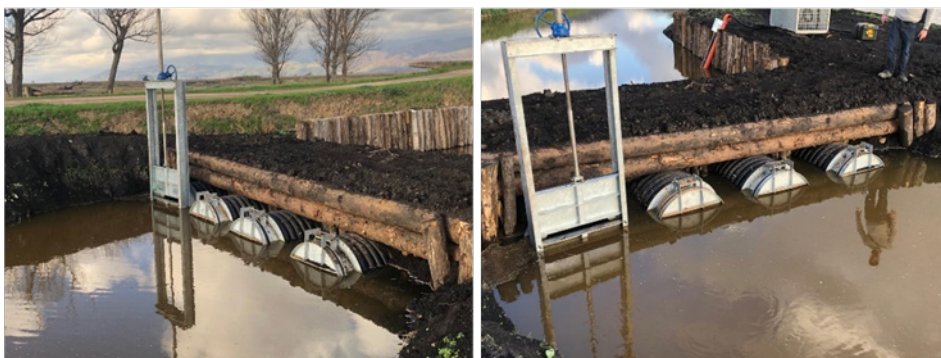
Figure 4-6 Photos of the pipes with clapet valves through the threshold (Figure 4-5) (Photo: ADBS)

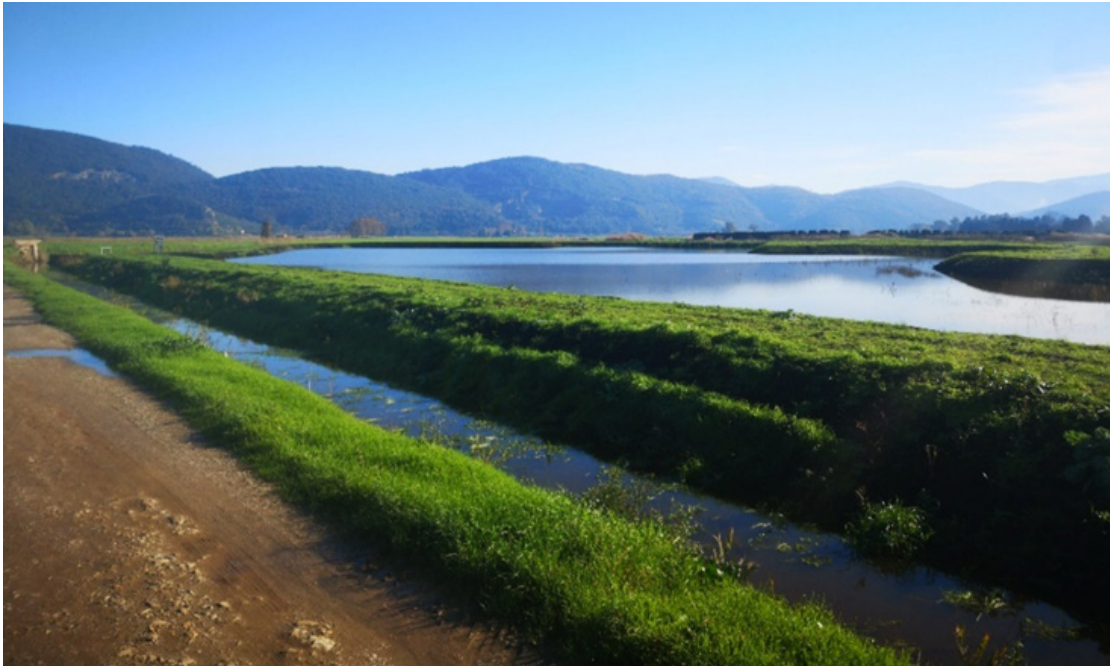
Figure 4-7 The sedimentation basin after completion (Photo: ADBS)

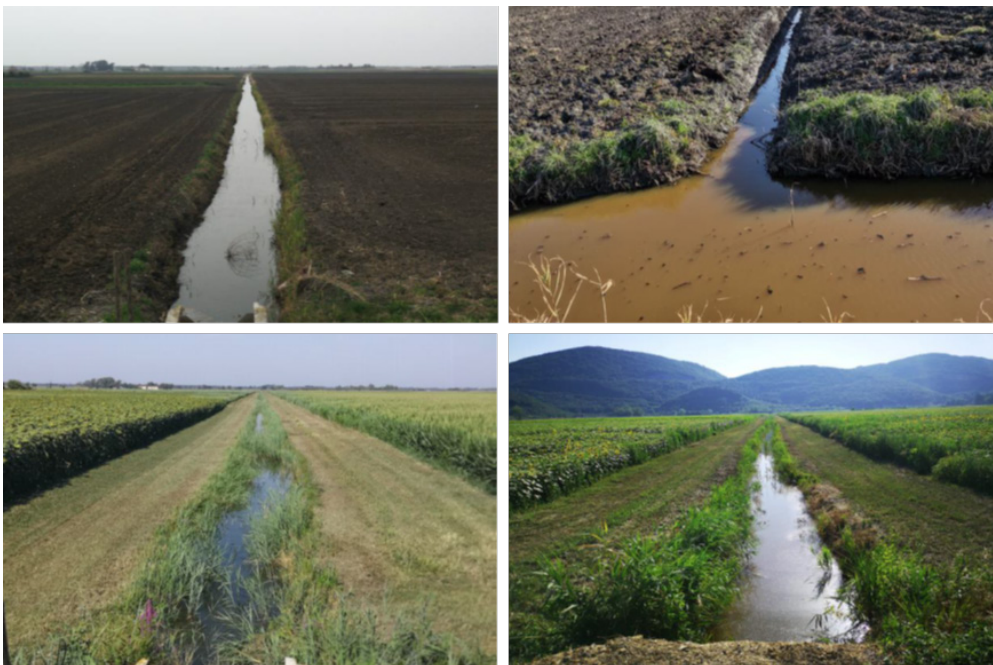
Figure 4-10 The Fosetto (left) and Fossacio (right) canals before (upper) and after (lower) modification. (Photos: ADBS)

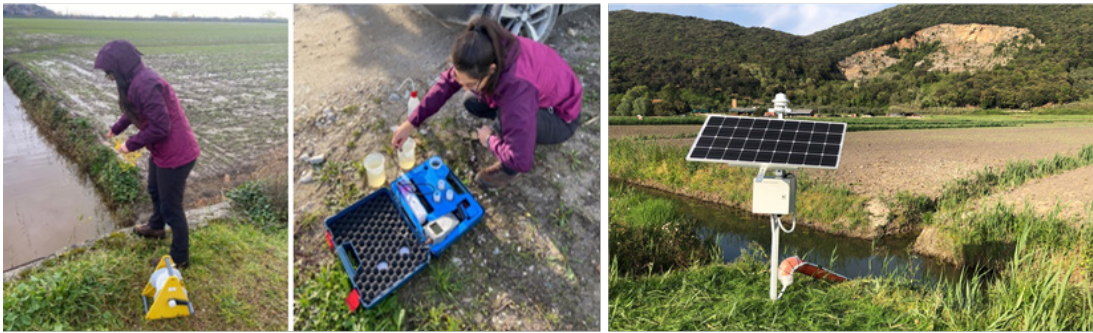
Figure 4-12 Manual periodic sampling (left) and continuous, automatic monitoring system (right) (Photo: ADBS)

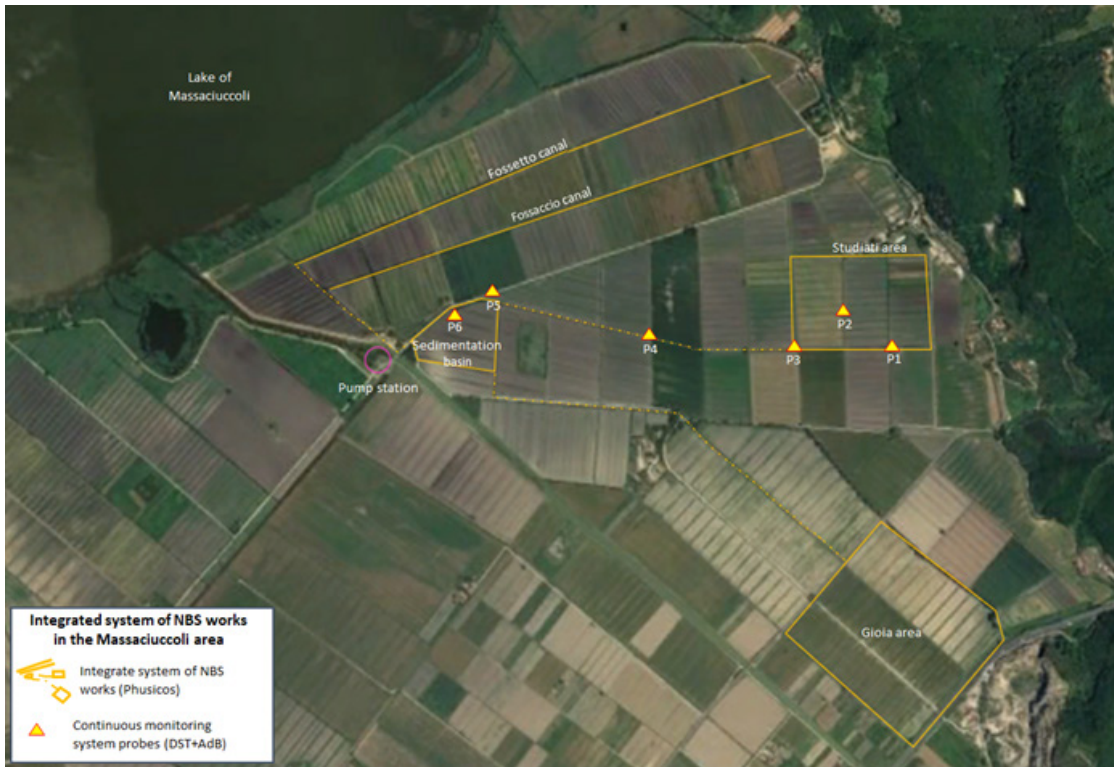
Figure 4-14 Overview of probes (yellow triangles) for automatic, continuous monitoring Of surface water parameters in the study area.

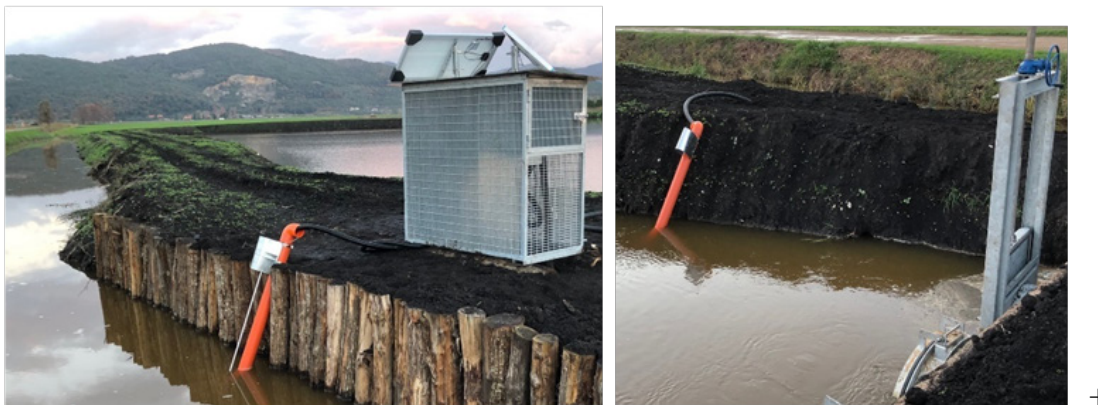
Figure 4-15 Photos of the monitoring probes at the intake and outtake of the sedimentation basin. Their locations are marked in Figure 4-5 (Photo: ADBS)

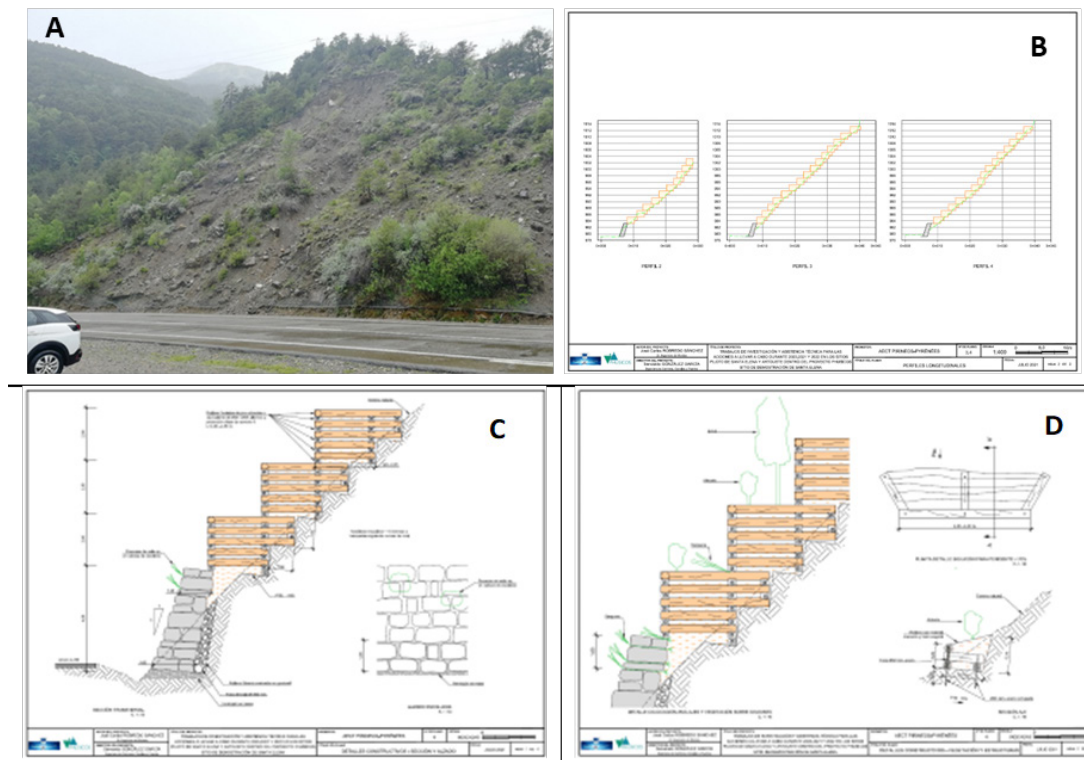
Figure 5-2 A) The till slope at Santa Elena in June 2019. The original net solution can be seen in the lower part of the slope, along the road. B) Three different longitudinal profiles, showing the gradient and the distribution of the wooden gabions along the till slope. C) Construction details showing the dry stones wall and wooden gabions. D) Construction details showing the vegetation to be planted, trees and bushes.

Two access roads were built. The first on the left side of the site, to build up the first five terraces. This first access was then to be replaced by another on the upper right side, taking advantage of an existing tractor road to the side of the slope. The first access road was used until the gradient was too steep for the construction machines. The terraces are built as an access road into the slope, large enough to allow the path of mini construction

machines: a mini dump truck and a mini excavator. The wooden gabions closest to the access road are first filled to allow access for the construction machines. They are overfilled with sediment to ensure that the wooden gabions are not broken by the weight of the construction machines. Then the second gabion is being filled. Once, all the gabions are filled, the farthest gabion along the access road is prepared with the adequate level of sediment and organic soil for the planting. The same operation is being done until the gabion closest to the access road is finally prepared. Then the terrace is ready for the plants to be used, and the next terrace level is built the same way.

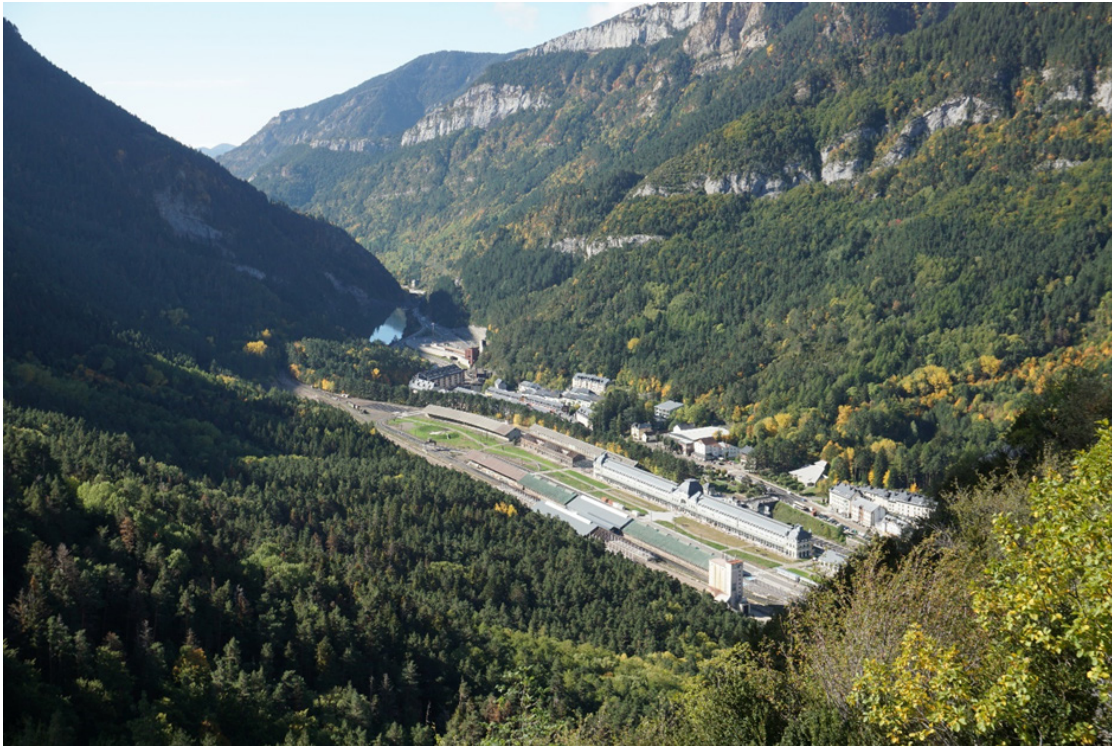
*Figure 5-5 The Los Arañones railway station in Canfranc. The forests in the surrounding hill slopes were planted in the beginning of the 20th century.*

In the example from Canfranc, some 20 km north of Jaca, Aragon, Spain, large scale measures were implemented in the beginning of the 20<sup>th</sup> century to protect the village and particularly the railway station of Los Arañones (Figure 5-5). The slopes at the time were mainly barren pastures with some open forest and snow avalanches were the main threat in addition to debris flows and rockfall. To mitigate the hazards, the Spanish government conducted a 10-year program of civil engineering works and reforestation. Many walls and barriers both of dry stone masonry and use of cement were constructed in release areas and in snow avalanche and debris flow paths. At the same time, access paths for people and transport of materials with horses and donkeys were constructed. These civil engineering works were followed by a huge reforestation project, in which

Today, the village of Canfranc experiences few snow avalanche- and landslide events. Occasional large avalanches may reach close to infrastructure, but no damage has been recorded for the last decades. Except for the highest zones of the valley side, the area appears as a largely forested valley (Figure 5-5) and the walls, access paths as well as other preventive structures are only seen when hiking in the forests, as for the measures in Biescas.

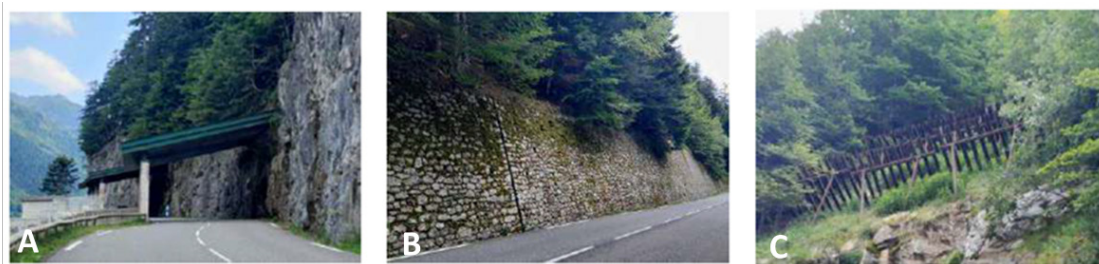
*Figure 5-7 Photos of older existing measures. A) Galleries for snow avalanches installed at the confluence of Zone 2 with the road. B) Masonry wall built at the intersection of Zone 4 with the road. C) Avalanche fences that act as shields against falling blocks at the intersect of Zone 3 with the road. (Photos by EGTC Pirineos- Pyrénées)*

Zone 2 represents a snow avalanche path with a very steep slope gradient. This path can also act as a channel for rockfall from source areas in zones 1, 2 and 3. The trajectories of these rockfall lead to galleries over the road (Figure 5-7 A), built for snow avalanche protection. These prevent larger block to reach the road but because they have a gridded roof, smaller block can still fall on the road.

affecting Zone 4. Blocks from this step can be larger than  $1\text{m}^3$  and reach high velocity and increasing energy on the steep slope. Where Zone 4 meets the road, a wall has been built (Figure 5-7 B) to prevent blocks from falling onto the road. Avalanche fences were constructed along the road in Zone 3 (Figure 5-7 C) that also stop falling rocks. The municipality mounted an additional 200 m of rockfall nets in 2022 (Figure 5-9, A) to protect the road section where a fatal accident occurred in 2013.

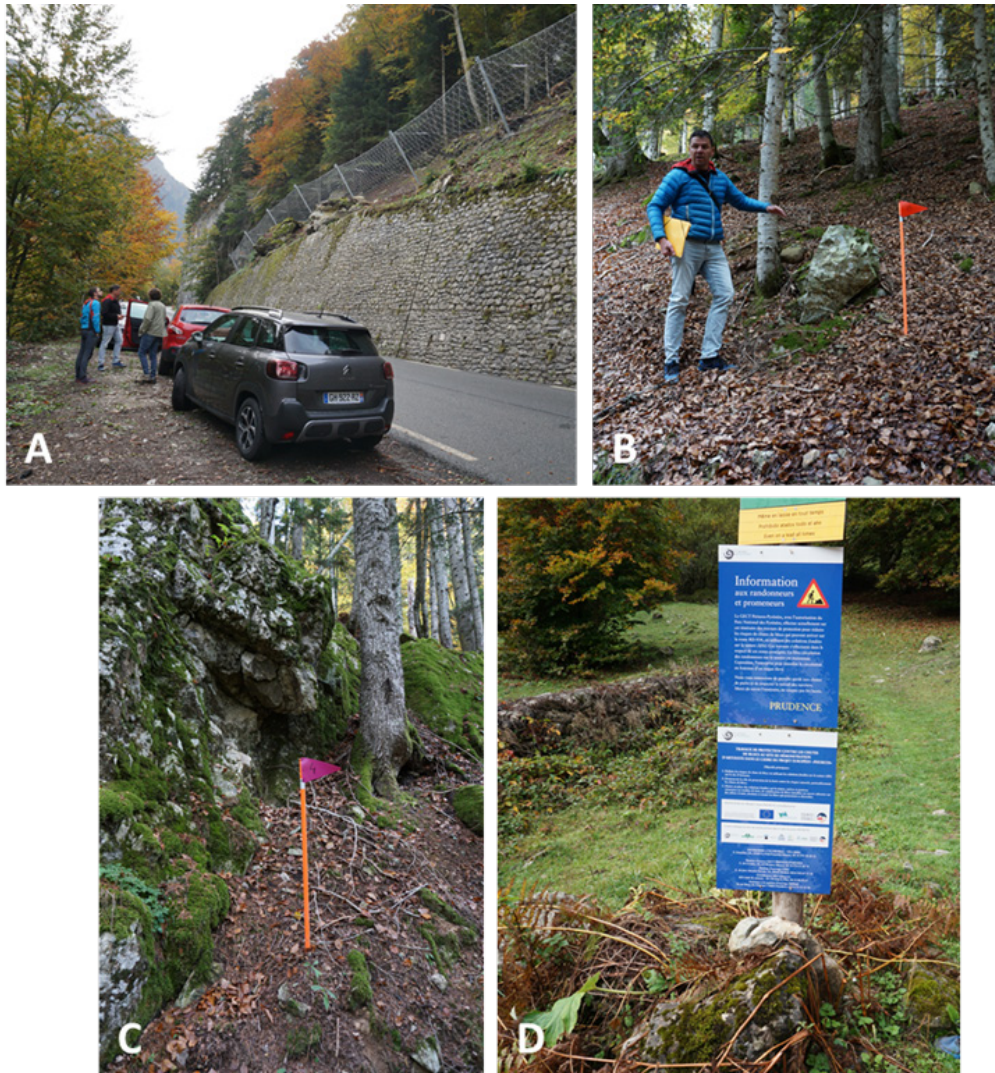
Figure 5-9 A) Newly established rockfall nets in one section of the slope at Artouste. B) A loose boulder, which is flagged to indicate type of protective structure to be implemented. C) Rock ledge, potential source of rock fall, flagged for NBS protective measures. D) Poster at the Artouste slope, informing about the project and the NBS measures to be implemented.

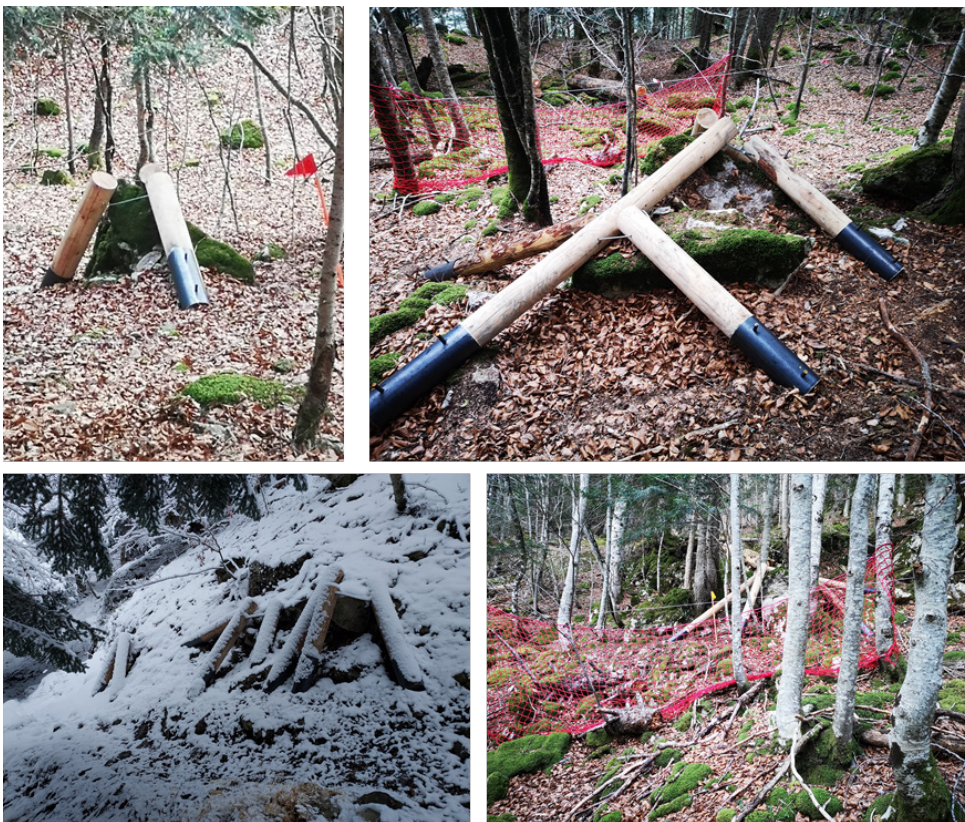
Figure 5-12 Examples of implemented protective structures (based on design principles of *Feil! Fant ikke referanse*kilden. in the slope at Artouste (Photo: S. Fábregas)

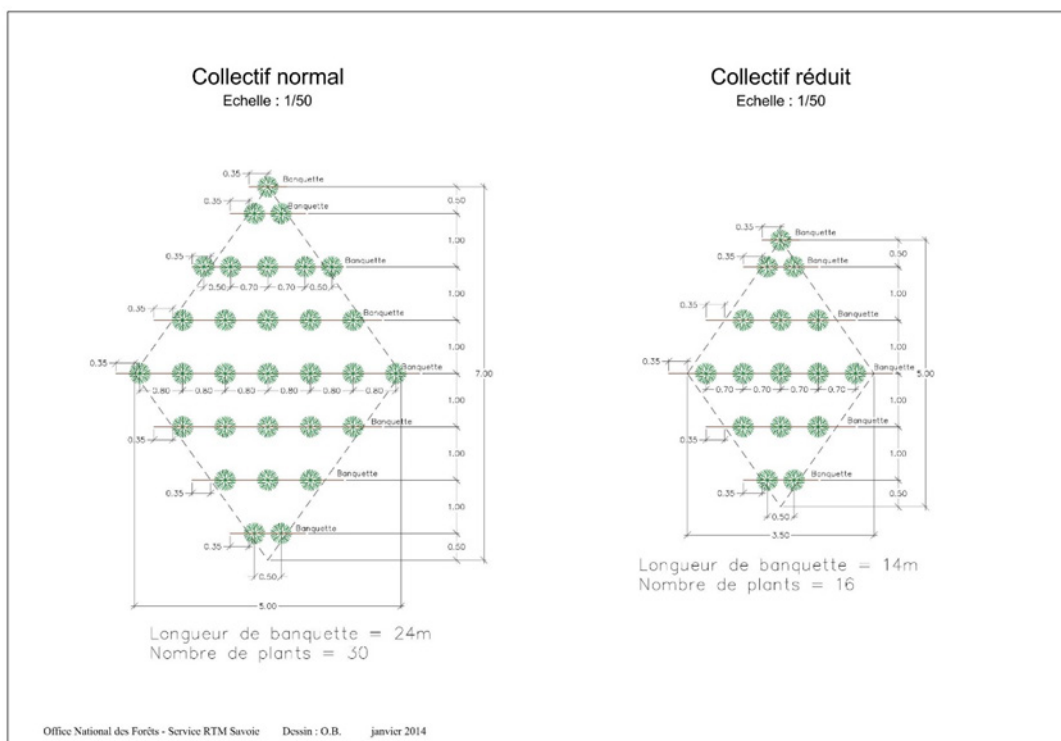
Figure 5-13 Design example of the planting in two different configurations, 7x5m / 30 plants (left) and 5x3,5m / 16 plants (right), respectively.

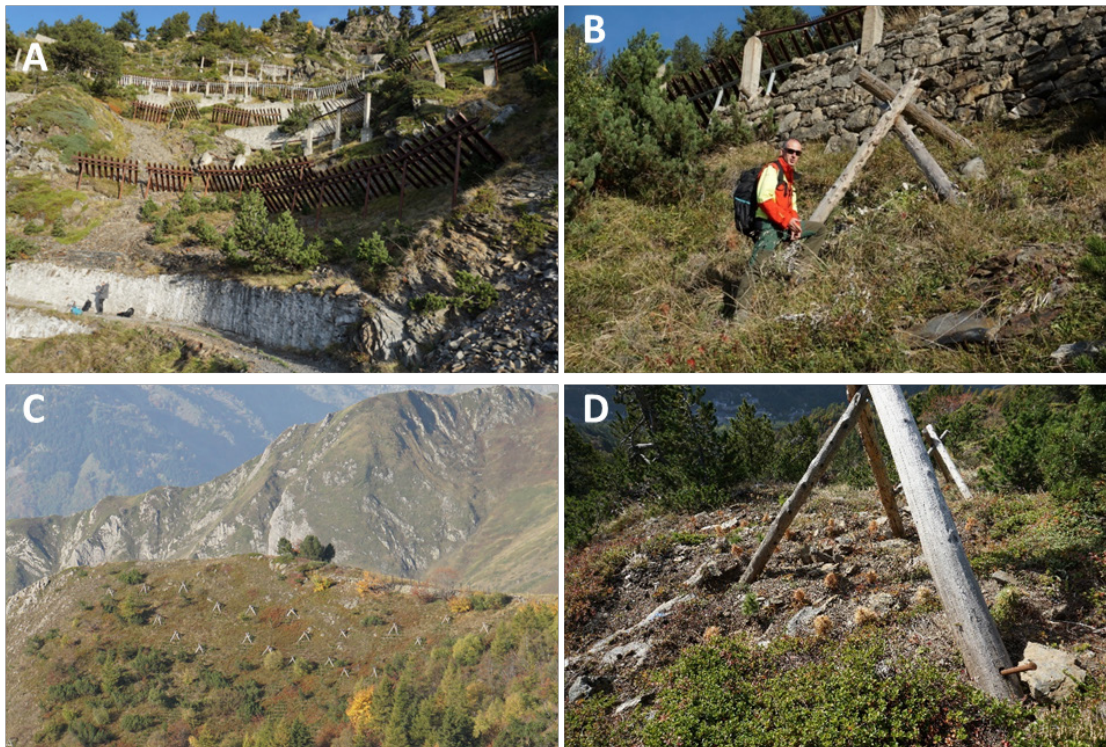
*Figure 5-14A) 'Grey' structures in the slope above the access road from the helicopter platform to the construction site for the shelter. B) One of the tripods for protection of new plants. C) Tripods protecting plants in a more barren part of the avalanche release area. Natural forest and old grey structures can be seen in the foreground. D) Example of plant collection where most plants have died, but still enough for the purpose seem to survive.*

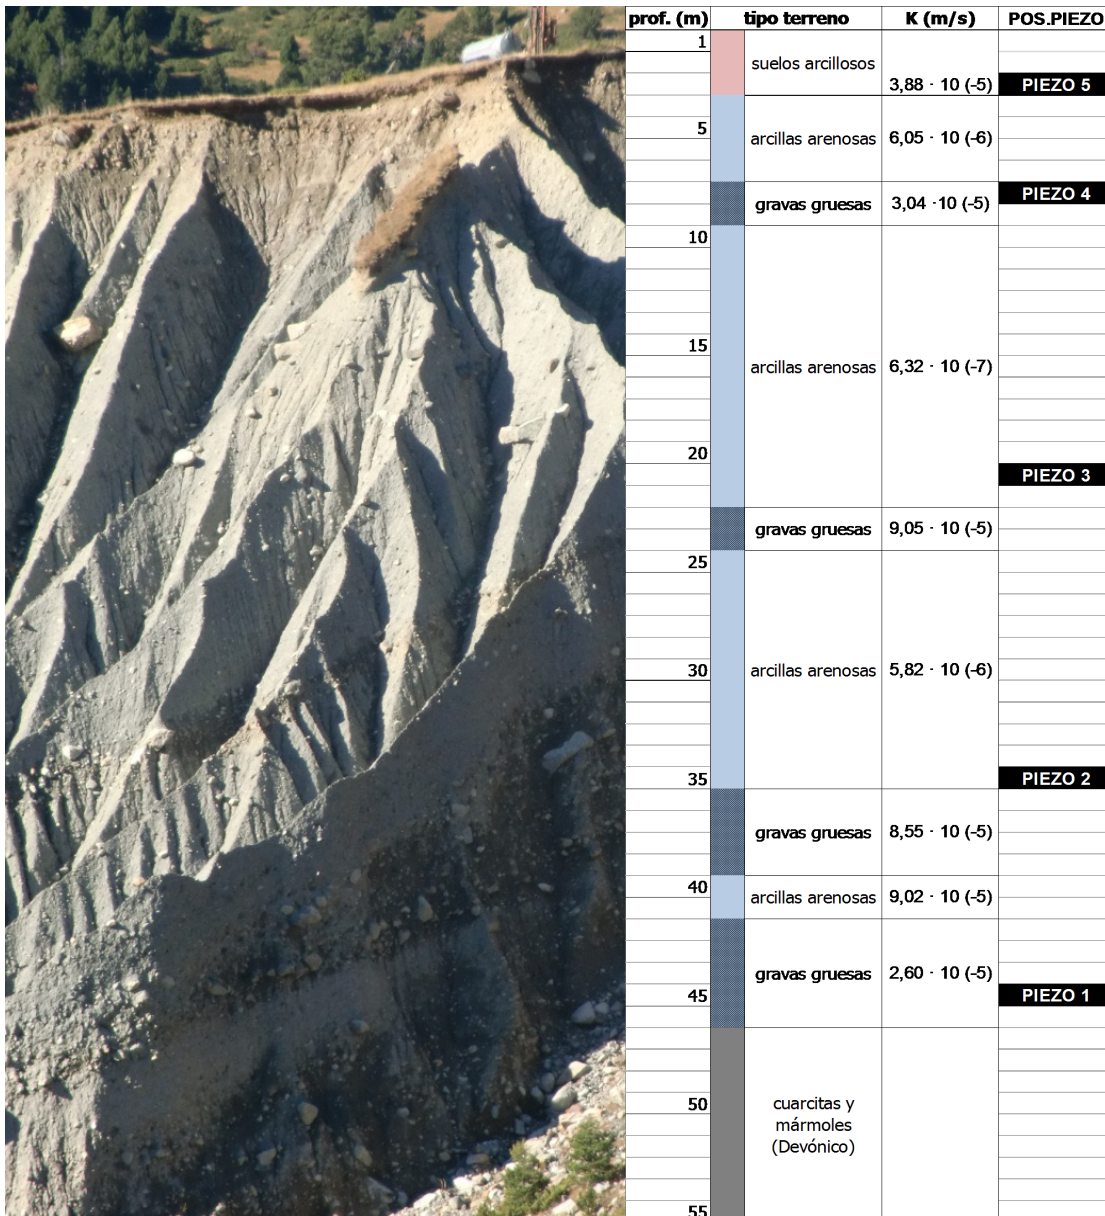
Figure 5-15 The complete till section at the Erill-la-Vall site, with stratigraphy and position of piezometers (figure by C. Raïmat).

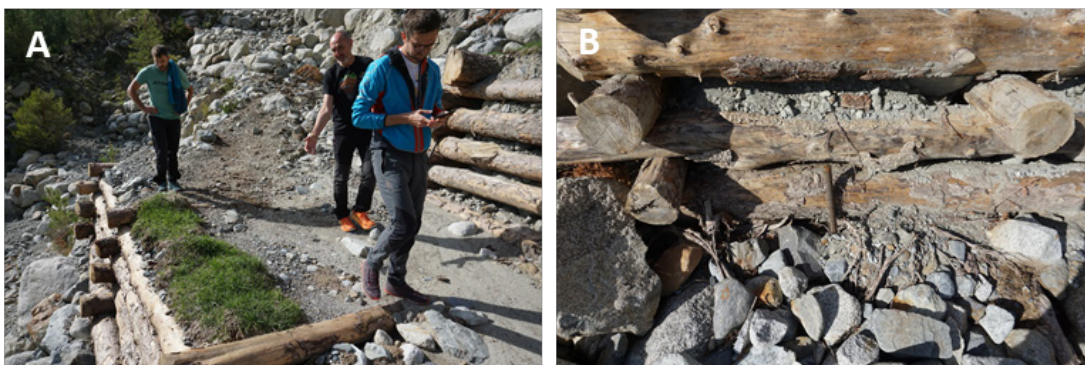
Figure 5-19A) Close-up of one of the terraces, with grass taken directly from one of the local pastures. All terraces will be planted with grass and other local bushes and trees. B) Close-up of the construction, anchored by iron rods, pushed at least 2 m into the ground.

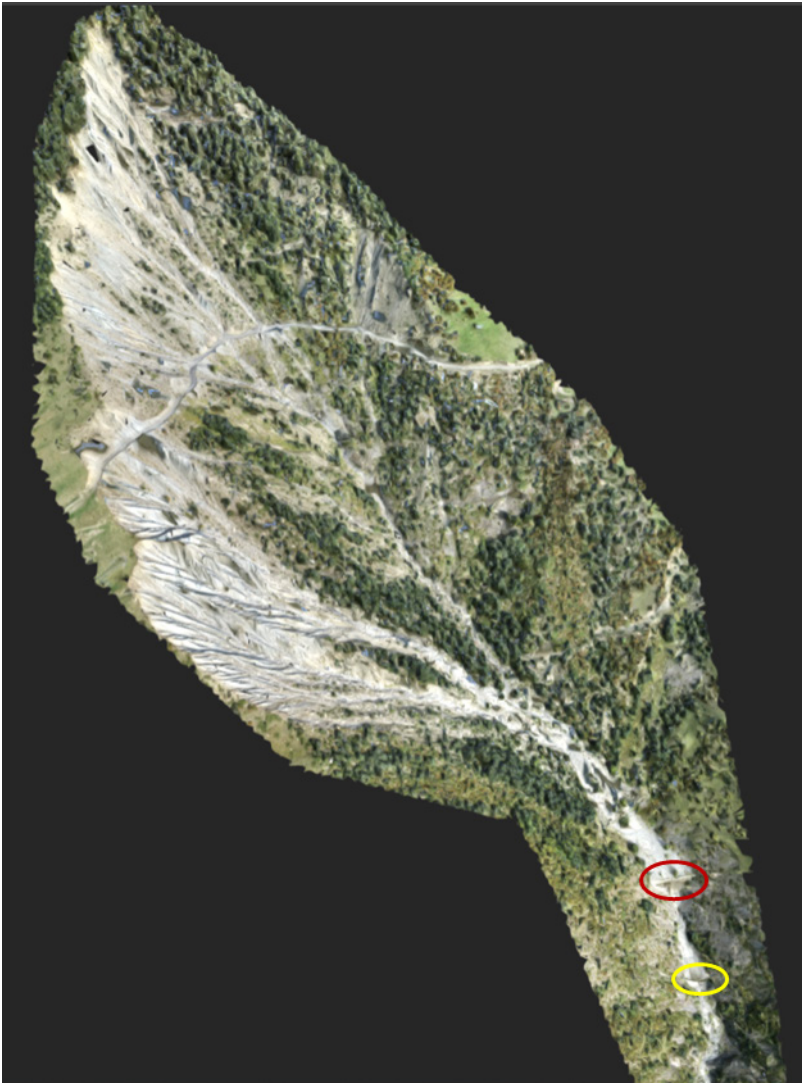
Figure 5-20 Detailed 3D model of the Erill-la-Vall site, before PHUSICOS measures are implemented. The older flexible and fixed barriers can be seen in the red and yellow circles, respectively.

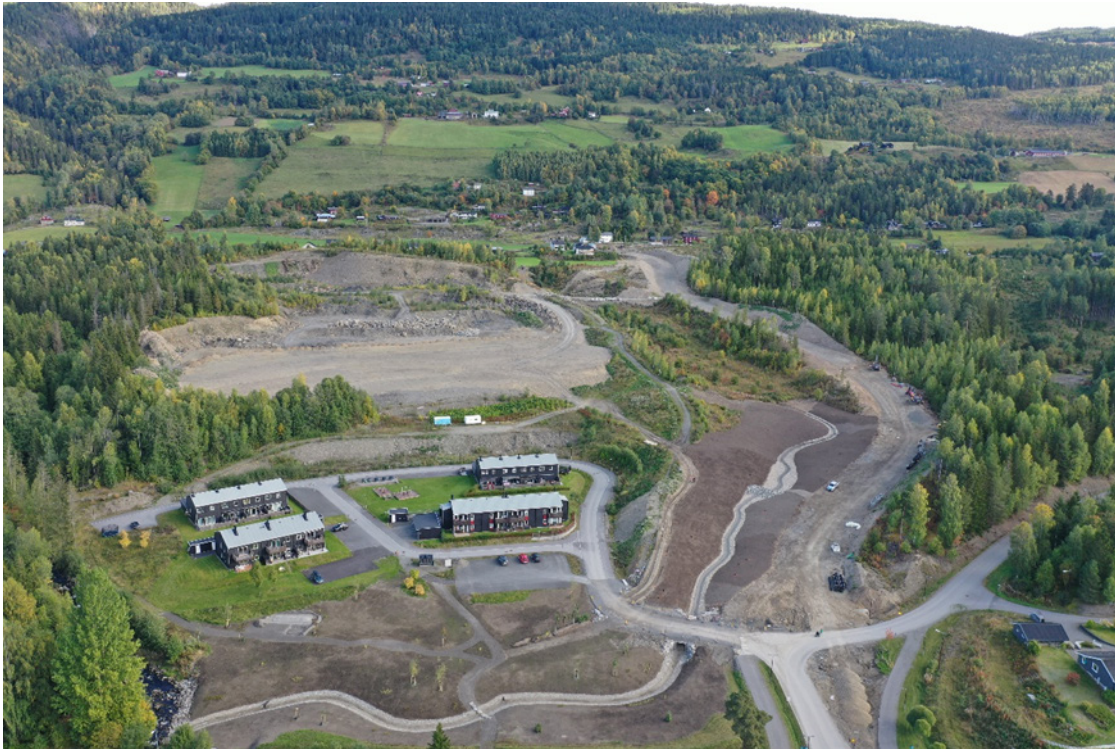
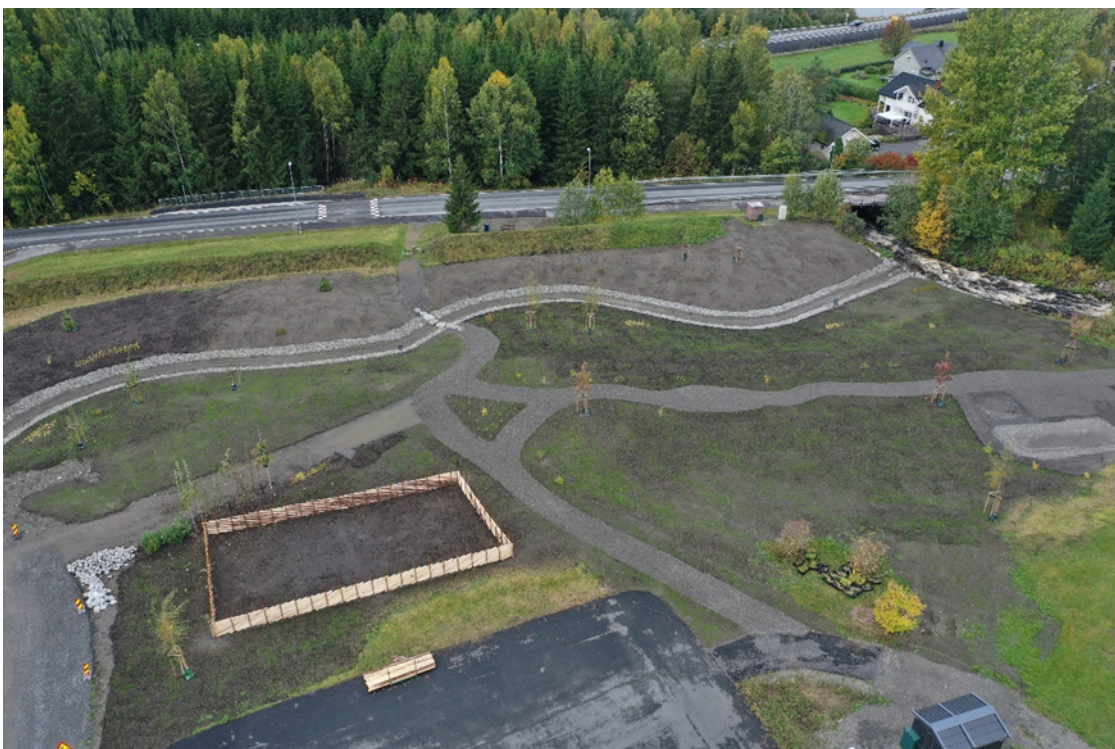
*Figure 6-5 Drone photos of the Trodalen site after completion of the interventions, but before planting is fully completed. Upper: Overview of the whole intervention. Lower: The lower part, below the houses, where Trobekken ends in Søre Brynsåa. One of the two fenced-in test fields for plants in the lower foreground. These were still not in place when the upper photo was taken. (Photos by Øyer municipality).*

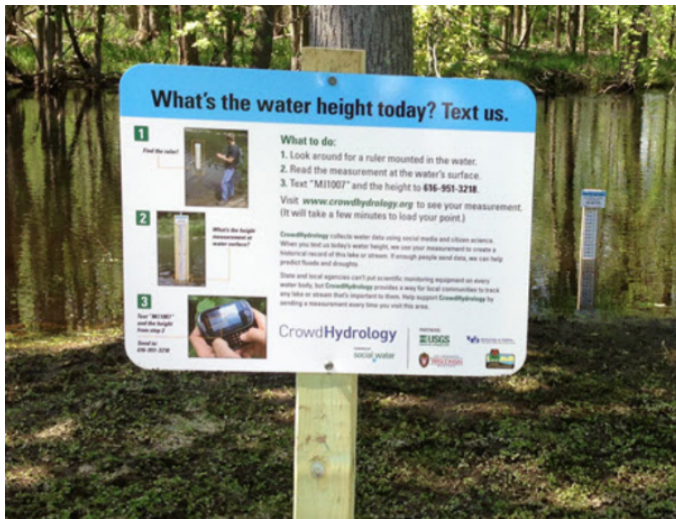
Figure 6-6 Example of crowdsourcing. A sign describes the NBS implementation, which purpose it serves, what sort of things to look out for indicating problems and provide an email address where citizens can send a photo and information if they observe something considered to be of interest.

- 1) Remote monitoring:
  - a) Publicly available aerial photography; comparisons after new campaigns
  - b) Optical or other types of satellite data, also for vegetation growth / health, repeat every 3-5 years
  - c) Drone based photogrammetry in regular (yearly) campaigns and after flooding events
- 2) Turbidity measurements in the channel or basin
- 3) Crowdsourcing (citizen observations of given parameters or anything unusual – Figure 6-6)
- 4) Inspections, at regular intervals and after flooding events

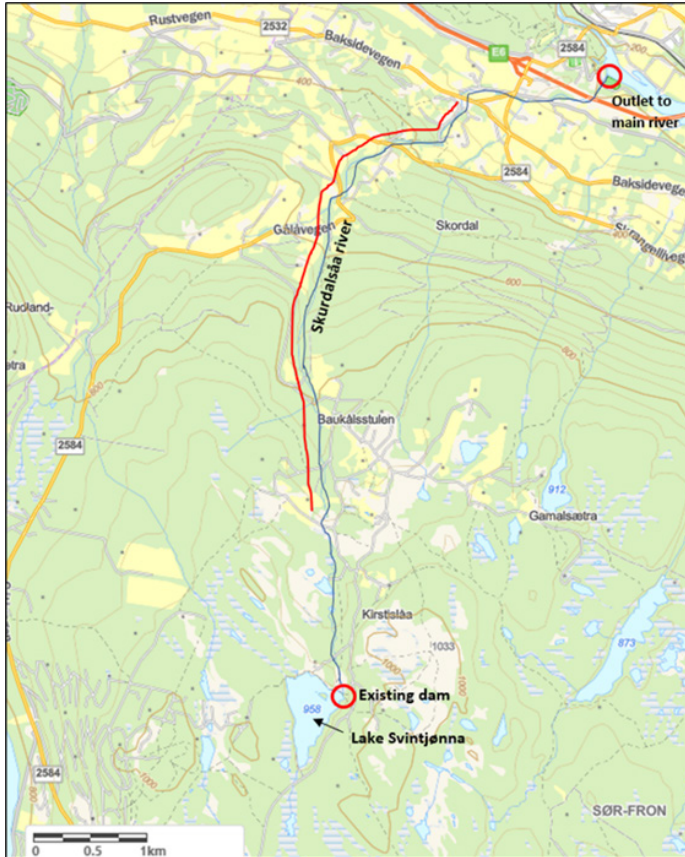
Figure 6-7 Map of Skurdalsåa. The red line along the river marks the section where selected clearing of vegetation is required.

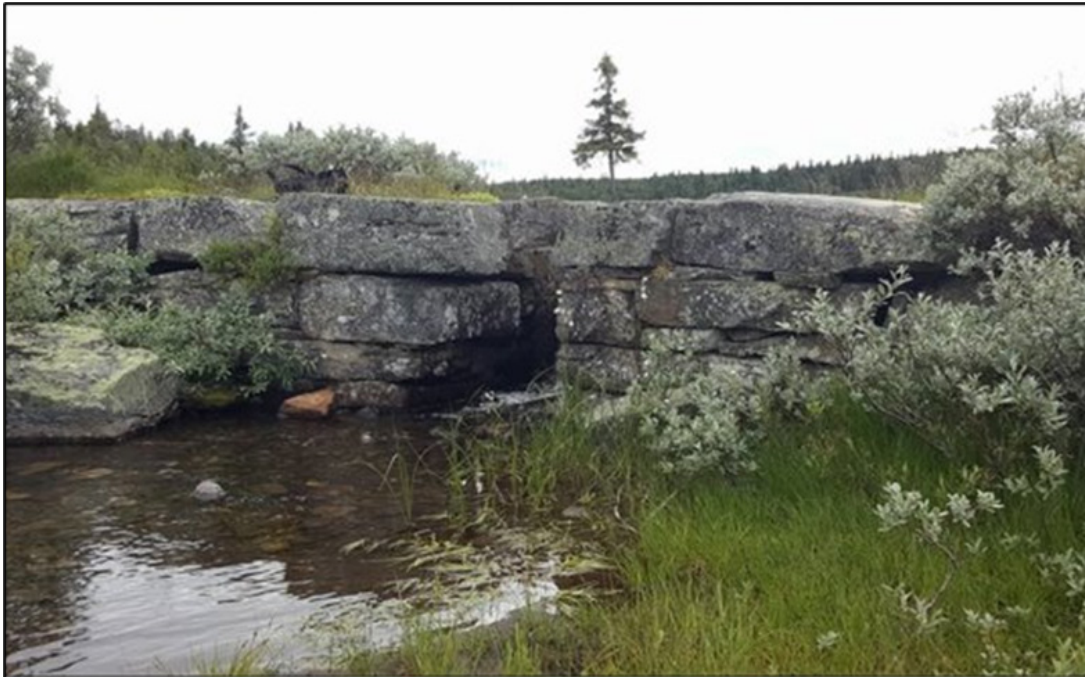
Figure 6-8 The existing old dam at Lake Svintjønna. The measures will increase the dam height by ca. 0.5 m and establish a new gate and threshold, with automatic monitoring of the lake level.

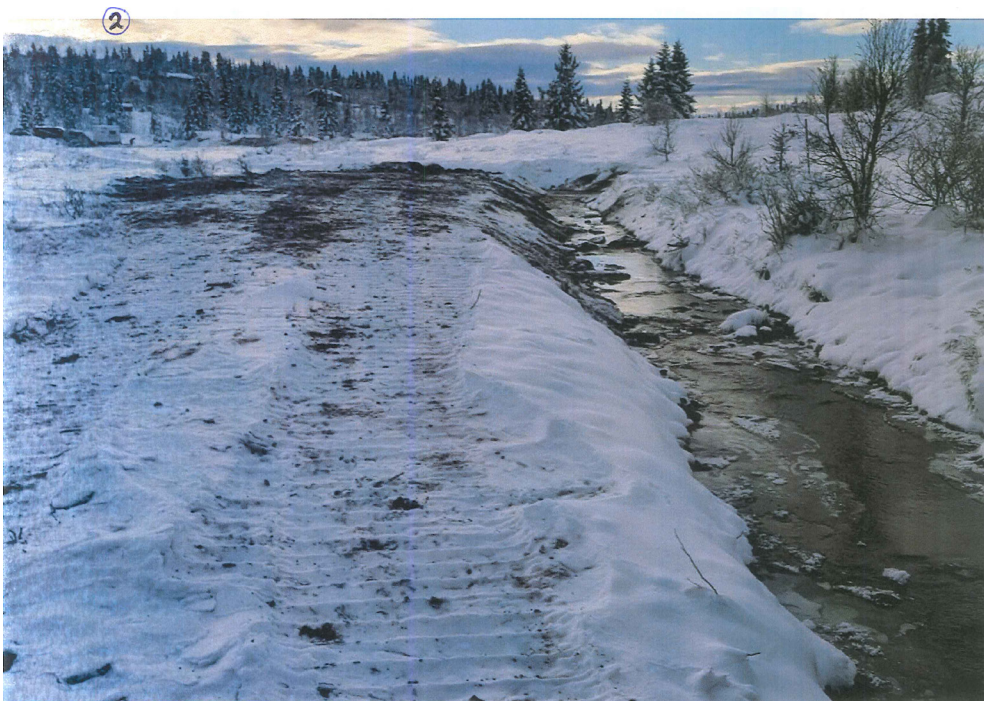
Figure 6-10 The new, deeper spillway from the Lake Svintjønna dam. (Photo: Ole Johan Kolseth)

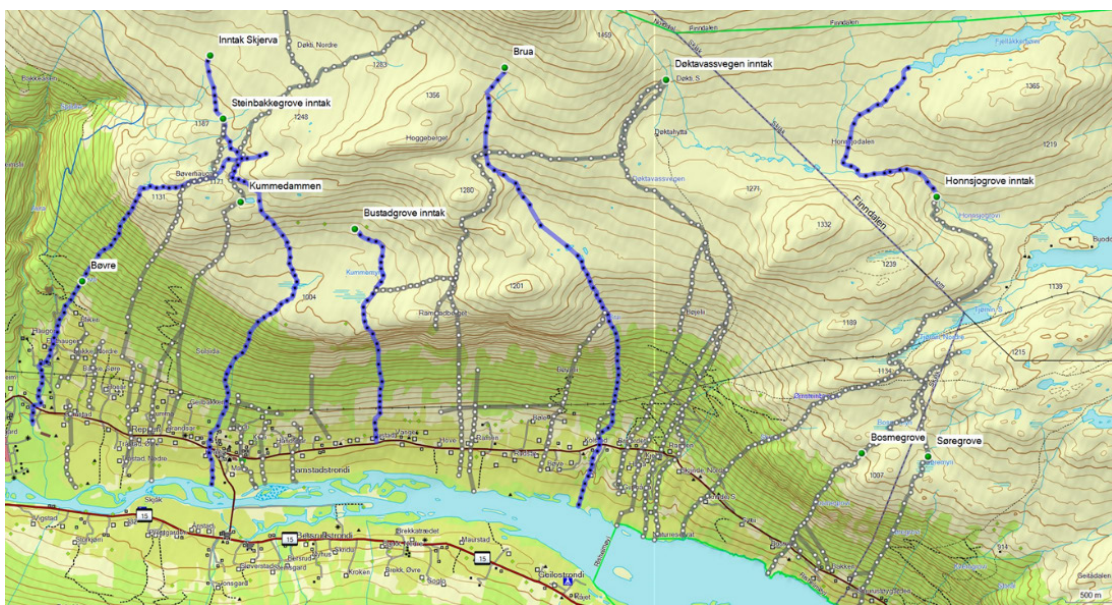
Figure 6-12 Map of old waterways in a part of Skjåk municipality. The grey lines are man-made waterways, whereas the blue lines are natural creeks.

During the LL sessions, it was clear that evaluating the use of old waterways for flood prevention was an issue that all stakeholders could agree upon. Because of the very modest annual precipitation in this region, most farmers established waterways leading water for irrigation as well as for household from lakes and ponds in the mountains surrounding the valley down to the fields and the farms (Figure 6-13 and Figure 6-14). The existing waterways were mostly established in the 18<sup>th</sup> and 19<sup>th</sup> century, and many are still in use. Although these waterways are made to mitigate drought, their flood retention potential has never been properly assessed. This was the topic for a joint field trip and LL session carried out on 17.08.2022. The six participants comprised the Mayor and Vice-Mayor of Skjåk municipality, the municipality's nature advisor, a representative from Innlandet County Authority, the facilitator from Skappa Knowledge Park and the WP2 leader from the PHUSICOS project. The field trip followed two of the waterways and inspected source lakes with their dry masonry dams. It was agreed to assess the possibilities further through a master thesis in hydrology. This has now been established at the University of Oslo, Department of Geosciences, but will not be concluded until June 2024. The thesis will assess the total capacity of all the waterways in municipality and discuss what modifications can be done to increase the flood retention capacity. The measures implemented at Lake Svintjønna in the Skurdalsåa intervention (above) is of interest as many of the dams sourcing the waterways have similar possibilities for modification. Furthermore, similar waterways are established in many of the Gudbrandsdalen Valley municipalities, and the upscaling potential is therefore great.

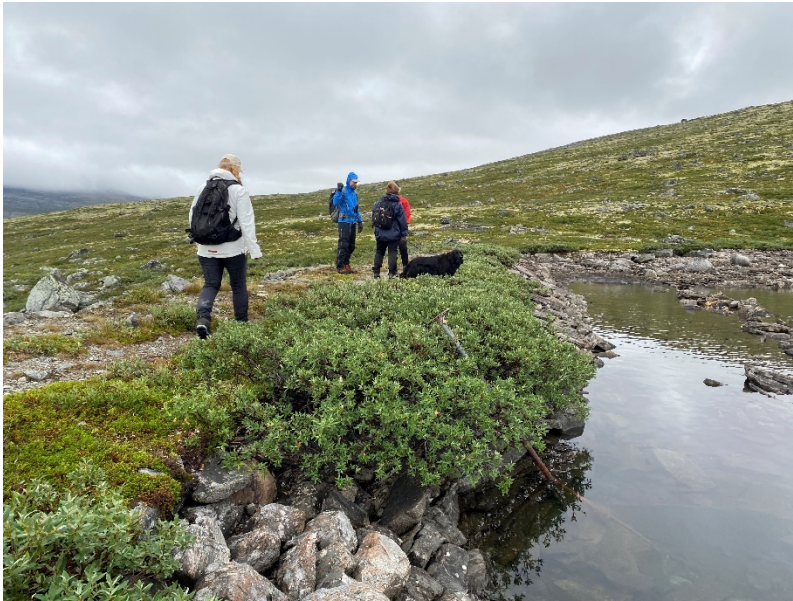
*Figure 6-13 Example of dam with controllable gate (rod with wheel) sourcing one of the waterways.*

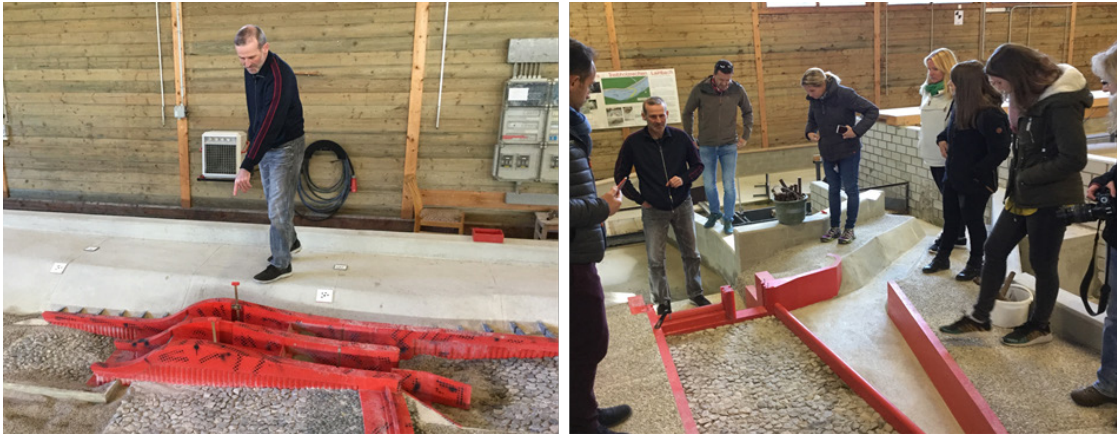
Figure 7-3 Visit to the hydraulic test facility, where all measures to be implemented were tested hydraulically in down-scaled models.

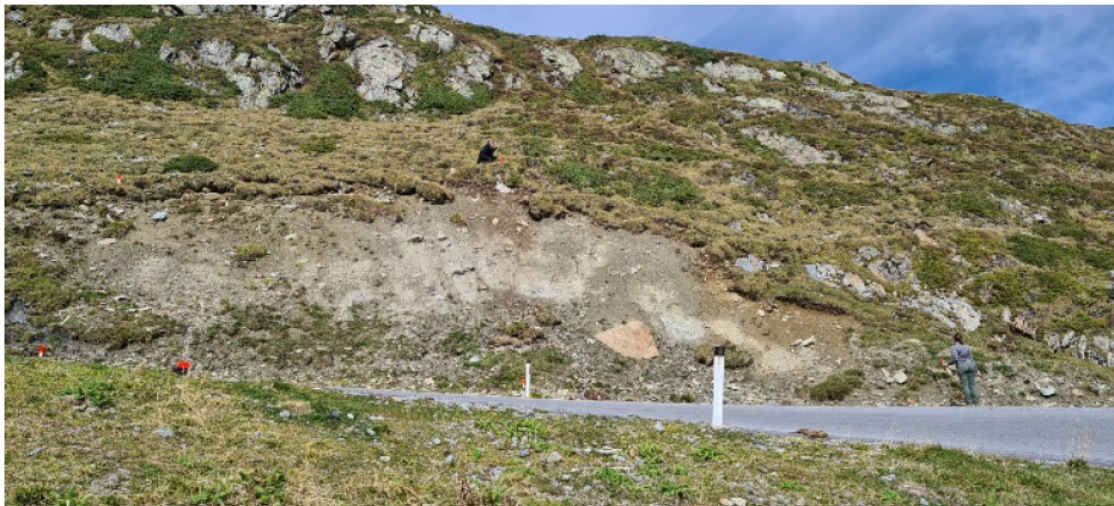
*Figure 8-3 One of the road-cut sites where the seed-bacteria mixtures are deployed at larger scale (Photo: Sabine Kraushaar).*

- Implementation by deploying seed mixtures through hydroseeding at a total of 10.000 m<sup>2</sup> on road cut slopes at 6 different test sites (Figure 8-3) and one ski slope site.
- Vegetation survey to further investigate the germination of seed mixtures.
- Deinstallation of experimental test plots.
- Monitoring and evaluation of results from the larger scale implementation to follow in summer / fall 2023 (outside PHUSICOS).
